# Memo

**To: Bob Schaefer, P.E., Asst. Dir. of P.W.****Date: March 26, 1998****From: Randy Lyman, Pretreatment Coordinator****Re: Closed Burger Station Inspections 3/25-26/1998 you requested.****CC: Ed Malter, Pretreatment Inspectors, Food Inspection(Health)**2456 N. Kansas Expressway

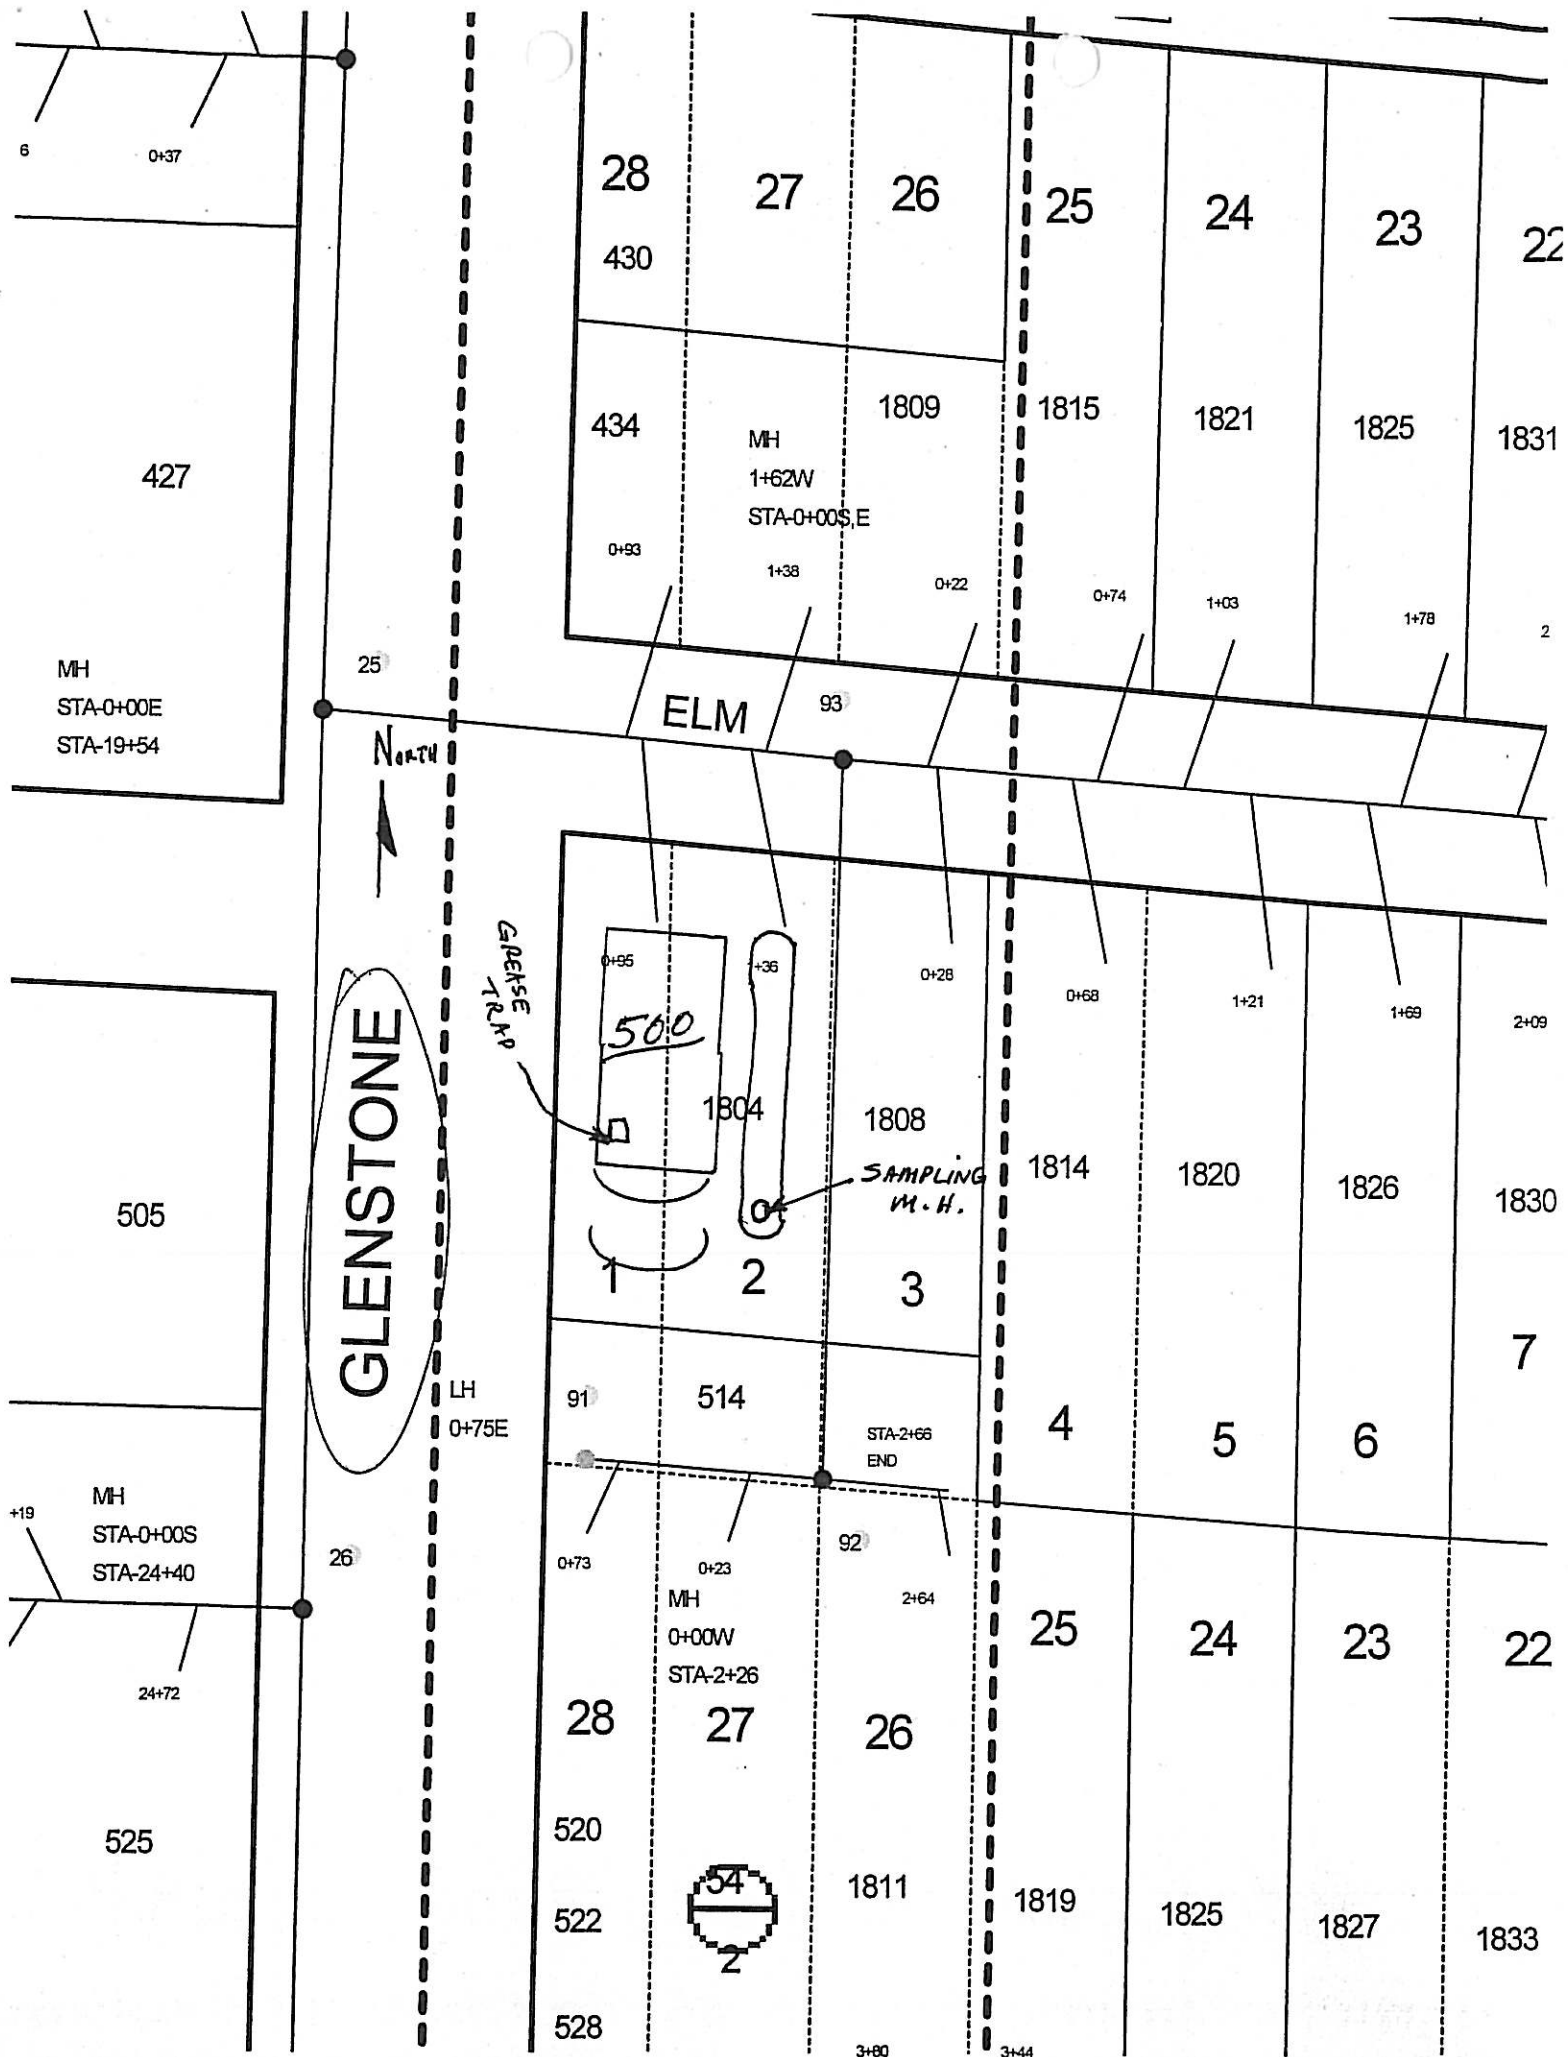
MH A7  
0+27S  
T-1266.00  
FL-1257.81

MH A6  
0+00N,W  
T-1265.60  
FL-1257.48

SAMPLING M.H.

GREASE TRAP

S. CAMPBELL

MH A4  
1+90N,0+00S  
T-1267.20  
FL-1255.63

Closed. Sampling manhole present, no apparent seal between wall and floor, invert shelves full of dirt, no ram-nek visible under ring and lid casting. Pipe has been sawed out to allow sampling. No grease noticeable in sampling manhole. No outside grease trap. Building was locked and all fixtures removed. By looking through the window it appears to have a 20(?) pound grease trap in the floor where the 3-vat sink used to be. Had a Crouch type casting. No sign of grease in City sewer downstream from connection.
